**Flood Control Project Maintenance  
Levee Inspections**

**Fall 2018 Levee Maintenance Deficiency Summary Report**

<b>RD0544</b>	Overall LMA Rating	Total LMA Miles						
<b>Reclamation District No. 0544 Upper Roberts Island</b>	<b>U</b>	<b>10.20</b>						
Rated Item	Maintenance Deficiency				Enforcement		Design & System Obsolescence	
	M Miles	U Miles	M + 4U Miles	Threshold %	M Miles	U Miles	M Miles	U Miles
<i>Earthen Levee</i>								
Vegetation	1.18	4.95	20.98	205.66%		0.07		
Trim / Thin Trees	0.24	0.09	0.60	5.88%				
Encroachments	0.02	0.02	0.10	0.98%	0.39	0.11		
Animal Control	0.57	0.27	1.65	16.17%				
Slope Stability	0.04	0.01	0.08	0.78%				
Erosion / Bank Caving	0.03	0.09	0.39	3.82%				
Crown Surface / Depressions / Rutting	0.22		0.22	2.16%				
Flood Preparedness & Training	0.10		0.10	0.98%				
<i>Interior Drainage &amp; Piping Systems</i>								
Erosion Areas		0.01	0.04	0.39%				
<i>Supplemental</i>								
DWR Erosion Survey	0.04		0.04	0.39%				
DWR UCIP Field Study					0.19	0.05		
<i>LMA Totals:</i>	2.44	5.44	24.20	237.22%	0.58	0.23	0.00	0.00

**Flood Control Project Maintenance  
Levee Inspections****LMA District Cover Sheet****Fall 2018 Levee Inspection Results****Rec

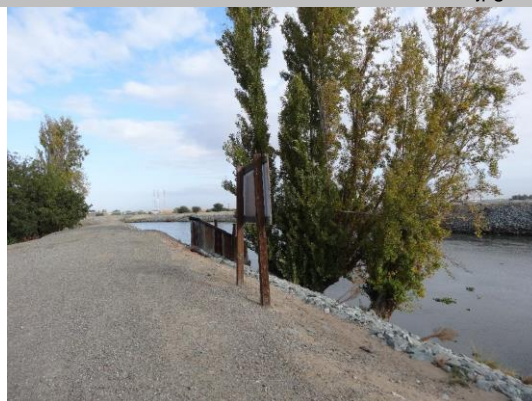
Photo 1 of 3 : UCIP\_FA\_2018\_41906\_41713.jpg

Comment Code					
Inspector Comment					
FS_ID:41906 DS_ID:22640 EP_NO: 4116 Repair Type: Non-Urgent Crossing Status: Found UCIP Comments: Need to contact owner to determine status.- a signboard on waterside shoulder and across the river.- no indicators on landside. FIELD_STRUCT_DESC: 8.625-inch steel natural gas pipeline through the levees and under the river, 3.9 feet below the crown. Waterside (WS) slope rock revetted. (Plans for installation of an 8.625-inch gas line under the San Joaquin River and through the levees authorized under Permit No. 4116, 1962 - Pacific Gas and Electric Company [PG&E]). [Additional Reference(s): DWR Levee Log, 2005. USACE San Joaquin O&M Manual 7, April 1964, (HLM 0.01)]. FS Date: 10/29/2013

WS view: a signboard indicating a gasline on levee shoulder.

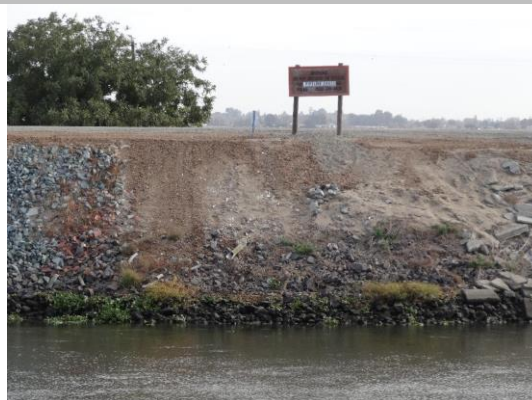
Photo 2 of 3 : UCIP\_FA\_2018\_41906\_41712.jpg

WS view: a signboard indicating a gasline across the river channel.

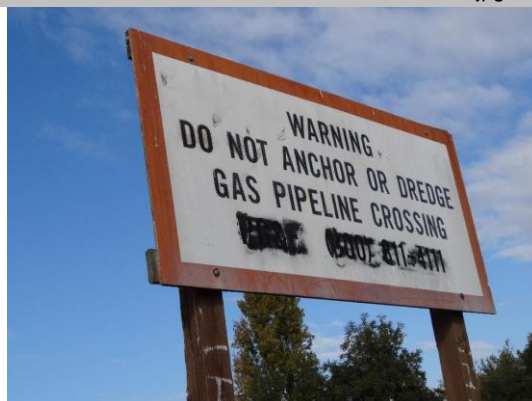
Photo 3 of 3 : UCIP\_FA\_2018\_41906\_41711.jpg

Comment Code						
Inspector Comment						
FS_ID:41906 DS_ID:22640 EP_NO: 4116 Repair Type: Non-Urgent Crossing Status: Found UCIP Comments: Need to contact owner to determine status.- a signboard on waterside shoulder and across the river.- no indicators on landside. FIELD_STRUCT_DESC: 8.625-inch steel natural gas pipeline through the levees and under the river, 3.9 feet below the crown. Waterside (WS) slope rock revetted. (Plans for installation of an 8.625-inch gas line under the San Joaquin River and through the levees authorized under Permit No. 4116, 1962 - Pacific Gas and Electric Company [PG&E]). [Additional Reference(s): DWR Levee Log, 2005. USACE San Joaquin O&M Manual 7, April 1964, (HLM 0.01)]. FS Date: 10/29/2013

WS view: closer view of a signboard indicating a gasoline on levee shoulder.

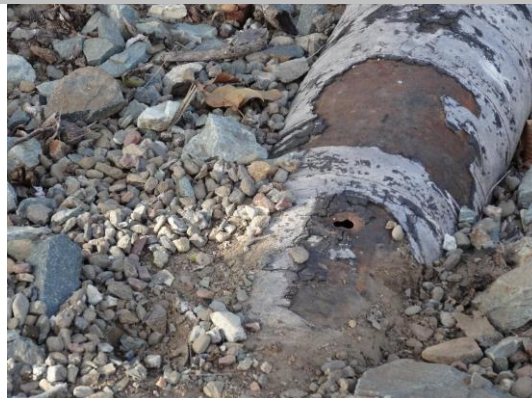
Photo 2 of 3 : UCIP\_FA\_2018\_23851\_41727.jpg

LM Start	0.01	Rating **	M	Issue No.	153 (cont)	
LM End	0.01	Issue Type +	En	Location *		
Category	Supplemental			GPS Latitude/Longitude		
				Start	End	
Item	DWR UCIP Field Study			37.870296 °	37.870296 °	
				-121.329826 °	-121.329826 °	
DWR ID	24713					
Comment Code						
Inspector Comment						
FS_ID:23851						
DS_ID:24713						
EP_NO: N/A						
Repair Type: Non-Urgent						
Crossing Status: Found						
UCIP Comments: Appears abandoned.May need proper abandonment.Pipe exposed on landside slope.						
FIELD_STRUCT_DESC: *ABANDONED* 12-inch steel pipe of an unknown purpose through the levee, 2 feet below the crown. Appears abandoned. Only visible on the landside (LS) slope. No pipe or other features visible on the waterside (WS).						
FS Date: 10/29/2013

LS view: a 12-inch steel pipe on levee slope. Holes on the pipe, appears abandoned.

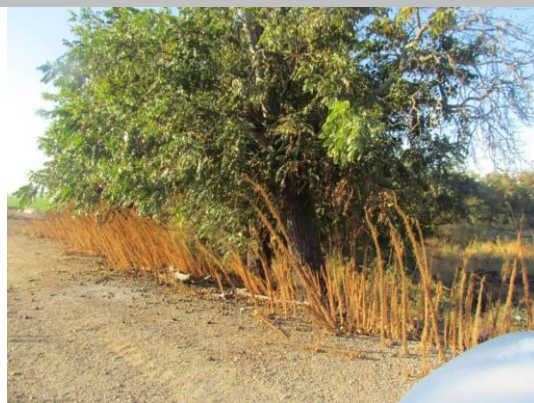
Photo 1 of 1 : FA\_2018\_RD0544\_108\_92\_20180906\_00066.jpg

LM Start	0.01	Rating **	M	Issue No.	92
LM End	0.01	Issue Type +	Ma	Location *	LS
Category	Earthen Levee			GPS Latitude/Longitude	
				Start	End
Item	Trim / Thin Trees			37.870285 °	37.870285 °
				-121.329822 °	-121.329822 °
DWR ID	DWR_RD0544_01_f_2014_92				
Comment Code					
T1 : Trim trees to at least five feet above ground level.					
Inspector Comment					
Untrimmed tree on landside slope.

Looking southwest at untrimmed tree on landward slope.

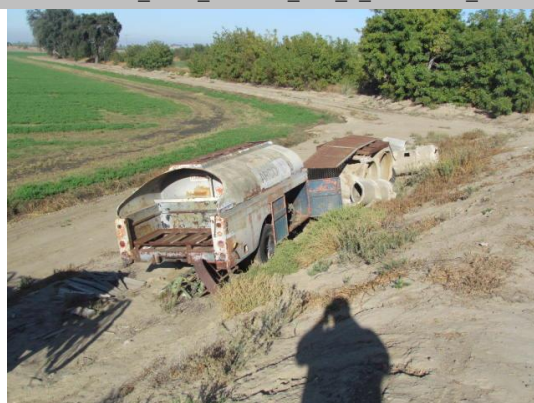
Photo 1 of 5 : FA\_2018\_RD0544\_108\_4\_20180906\_00005.jpg

LM Start	0.06	Rating **	M	Issue No.	4
LM End	0.19	Issue Type +	En	Location *	LS
Category	Earthen Levee			GPS Latitude/Longitude	
				Start	End
Item	Encroachments			37.869606 °	37.868163 °
				-121.329571 °	-121.328132 °
DWR ID	DWR_RD0544_01_s_2012_4				
Comment Code					
EQ : Equipment					
Inspector Comment					
Farm equipment and supplies stored at landside toe.

Looking west at equipment stored at landward toe fall 2015

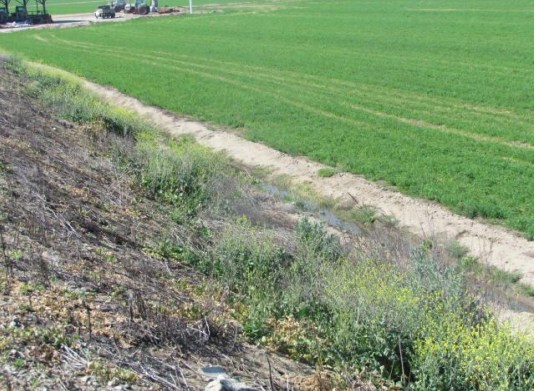
Photo 1 of 1 : FA\_2018\_RD0544\_108\_85\_20180906\_00061.jpg

Looking southwest at Irrigation ditch at landward toe.

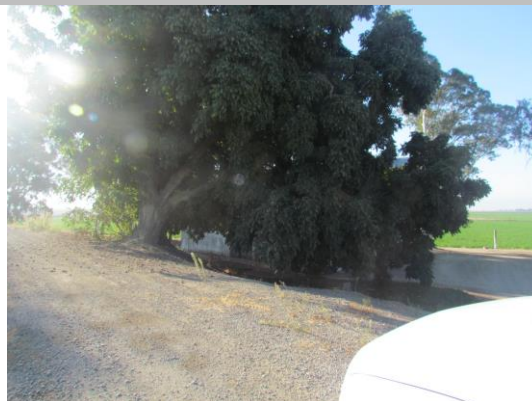
Photo 1 of 1 : FA\_2018\_RD0544\_108\_2\_20180906\_00002.jpg

LM Start	0.42	Rating **	M	Issue No.	2
LM End	0.42	Issue Type +	Ma	Location *	LS
Category	Earthen Levee			GPS Latitude/Longitude	
				Start	End
Item	Trim / Thin Trees			37.864958 °	37.864958 °
				-121.327142 °	-121.327142 °
DWR ID	DWR_RD0544_01_s_2012_2				
Comment Code					
T2 : Thin trees to allow visibility of the ground and room to flood fight.					
Inspector Comment					
Large untrimmed tree on landside slope.

Looking southwest at untrimmed tree on landward slope.

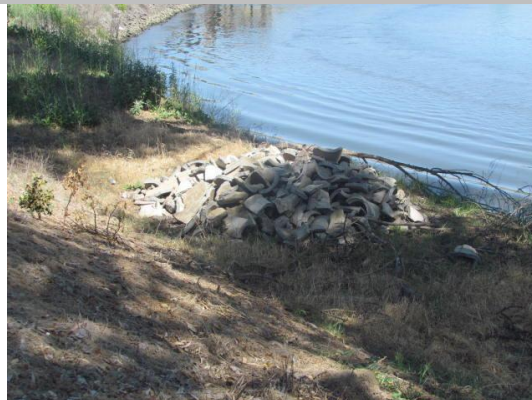
Photo 1 of 1 : FA\_2018\_RD0544\_108\_1\_20180906\_00001.jpg

LM Start	0.45	Rating **	M	Issue No.	1
LM End	0.45	Issue Type +	En	Location *	WS
Category	Earthen Levee			GPS Latitude/Longitude	
				Start	End
Item	Encroachments			37.864713 °	37.864713 °
				-121.326708 °	-121.326708 °
DWR ID	DWR_RD0544_01_f_2013_1				
Comment Code					
MA : Material					
Inspector Comment					
Old broken concrete pipes on waterside berm.

Looking northeast at broken concrete piping on waterward berm.

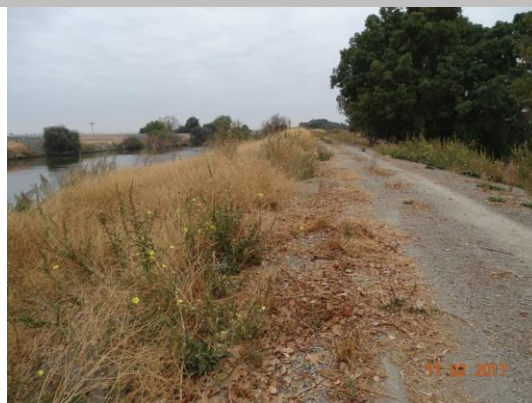
Photo 1 of 2 : FA\_2018\_RD0544\_108\_3\_20180906\_00003.jpg

LM Start	0.48	Rating **	U	Issue No.	3
LM End	0.67	Issue Type +	Ma	Location *	WS
Category	Earthen Levee			GPS Latitude/Longitude	
				Start	End
Item	Vegetation			37.864578 °	37.863753 °
				-121.326210 °	-121.322835 °
DWR ID	DWR_RD0544_01_s_2012_3				
Comment Code					
V2 : Remove the wild growth other than native grasses from the levee slopes.					
Inspector Comment					
Dense vegetation on waterside and landside slopes.

Looking southeast at the waterside slope.

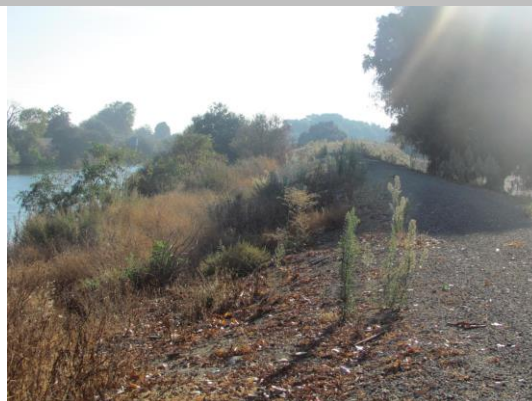
Photo 2 of 2 : FA\_2018\_RD0544\_108\_3\_20180906\_00004.jpg

Looking south at dense veg on waterward slope.

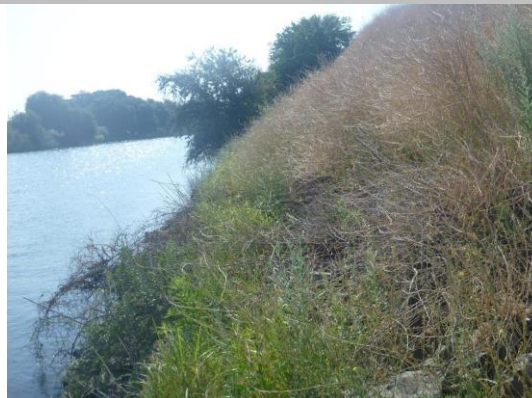
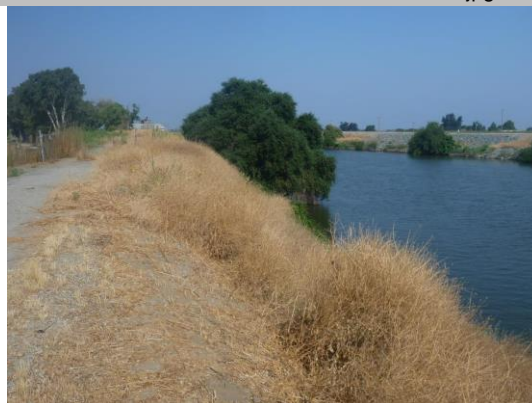
LM Start	0.64	Rating **	A/W	Issue No.	75 (cont)
LM End	0.64	Issue Type +	Ma	Location *	
Category	Supplemental			GPS Latitude/Longitude	
				Start	End
Item	2017 Storm Damage			37.863900 °	37.863900 °
				-121.323500 °	-121.323400 °
DWR ID	DWR_RD0544_01_f_2017_75				
Comment Code					
Inspector Comment					
Levee Evaluation Comments					
Description:Slope protection repairs are needed along the waterside slope due to erosion and riprap displacement from high water. Based upon levee inspections, it was determined the waterside levee slope is eroding, deteriorating, and degrading. The eroded levee sections need to be restored back to design standards to prevent further deterioration and damage.					
Site ID No:571					
Site Designation:LMA-477					
Repair Type: Erosion					
Rating:Area of Concern					
Field Date:8/10/2017					
Notes:

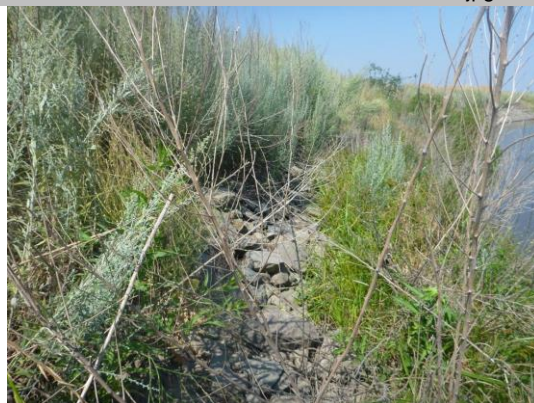
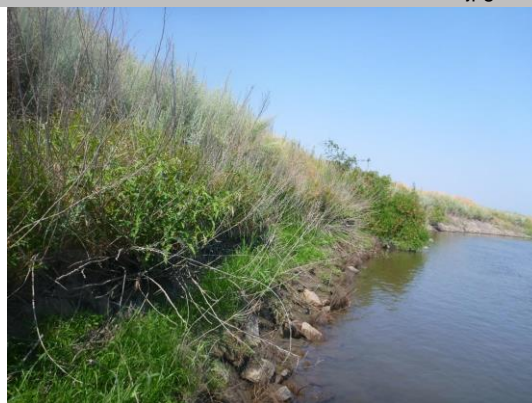
LM Start	0.99	Rating **	A/W	Issue No.	77 (cont)
LM End	1.02	Issue Type +	Ma	Location *	
Category	Supplemental			GPS Latitude/Longitude	
				Start	End
Item	2017 Storm Damage			37.860400 °	37.860200 °
				-121.320300 °	-121.319700 °
DWR ID	DWR_RD0544_01_f_2017_77				
Comment Code					
Inspector Comment					
Levee Evaluation Comments					
Description:Slope protection repairs are needed along the waterside slope due to erosion and riprap displacement from high water. Based upon levee inspections, it was determined the waterside levee slope is eroding, deteriorating, and degrading. The eroded levee sections need to be restored back to design standards to prevent further deterioration and damage.					
Site ID No:570					
Site Designation:LMA-476					
Repair Type: Erosion					
Rating:Area of Concern					
Field Date:8/10/2017					
Notes:

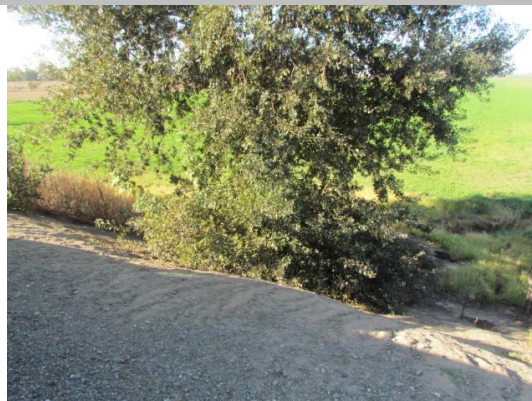
Photo 1 of 1 : FA\_2018\_RD0544\_108\_87\_20180906\_00062.jpg

LM Start	1.46	Rating **	M	Issue No.	87
LM End	1.48	Issue Type +	Ma	Location *	LS
Category	Earthen Levee			GPS Latitude/Longitude	
				Start	End
Item	Trim / Thin Trees			37.855416 °	37.855043 °
				-121.321171 °	-121.321122 °
DWR ID	DWR_RD0544_01_s_2015_87				
Comment Code					
T1 : Trim trees to at least five feet above ground level.					
Inspector Comment

Looking west at untrimmed tree at landward toe fall 2015.

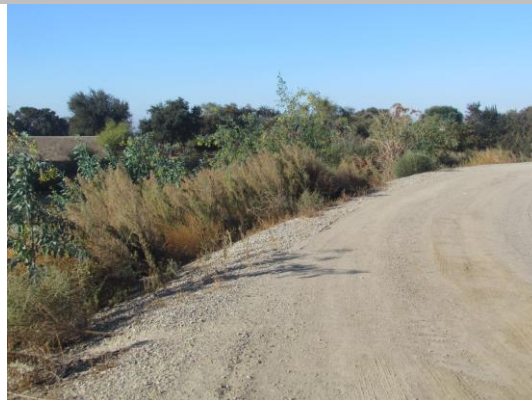
Photo 1 of 1 : FA\_2018\_RD0544\_108\_43\_20180906\_00034.jpg

LM Start	1.56	Rating **	U	Issue No.	43
LM End	1.76	Issue Type +	Ma	Location *	WS
Category	Earthen Levee			GPS Latitude/Longitude	
				Start	End
Item	Vegetation			37.854068 °	37.853980 °
				-121.321387 °	-121.324213 °
DWR ID	DWR_RD0544_01_s_2012_43				
Comment Code					
V2 : Remove the wild growth other than native grasses from the levee slopes.					
Inspector Comment					
Dense vegetation waterside slope.

Looking east at dense veg on waterward slope.

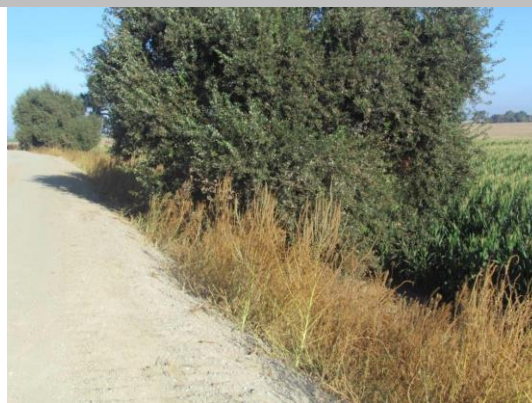
Photo 1 of 1 : FA\_2018\_RD0544\_108\_95\_20180906\_00068.jpg

LM Start	1.59	Rating **	M	Issue No.	95
LM End	1.59	Issue Type +	Ma	Location *	LS
Category	Earthen Levee			GPS Latitude/Longitude	
				Start	End
Item	Trim / Thin Trees			37.854299 °	37.854299 °
				-121.321865 °	-121.321865 °
DWR ID	DWR_RD0544_01_s_2018_95				
Comment Code					
T1 : Trim trees to at least five feet above ground level.					
Inspector Comment					
Untrimmed tree on landside slope.

Looking southwest at untrimmed tree on landward slope.

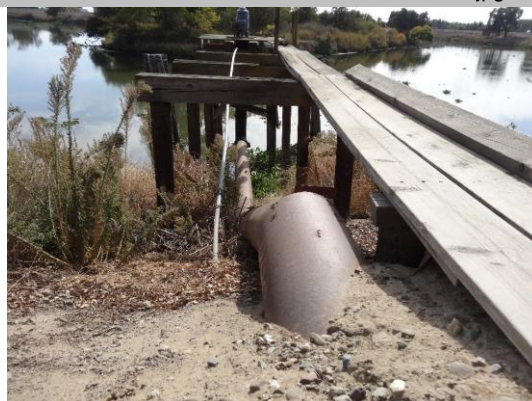
Photo 1 of 3 : UCIP\_FA\_2018\_51351\_41786.jpg

Comment Code						
Inspector Comment						
FS_ID:51351 DS_ID:22648 EP_NO: 4114 Repair Type: Non-Urgent Crossing Status: Found UCIP Comments: 12/22/2016: No signs of erosion or depressions found on either levee slope. Slope may have been backfilled but cause of original depression (likely a pipe integrity problem) may not have been addressed. Walkway still in poor structural condition. Downgraded this crossing from Urgent to Non-Urgent. (K. Fazel - UCIP)10/29/2013:- levee depression on both sides of the levee.- 2-inch electric conduit on waterside and service pole on landside.Walkway in poor structural condition. (P. Amatya - DWR) FIELD_STRUCT_DESC: 18-inch steel irrigation discharge pipe through the levee, 2 feet below the crown. Pump mounted on a pile structure pier in the river. Siphon breaker on the apex of the pipe on the landside (LS) slope. Concrete standpipe at the LS toe. 2-inch electrical conduit through the levee. Service pole at the LS toe. (Plans to install a pump, pump structure, and one 20-inch pipeline through the levee authorized under Permit No. 4114, 1962 - Katie M. Feck). [Additional Reference(s): DWR Levee Log, 2005, 14-inch pipe referenced, 4.2 feet below the crown. USACE San Joaquin O&M Manual 7, April 1964, (HLM 1.73), 20-inch pipe, 4.2 feet below the crown, referenced]. FS Date: 12/22/2016

WS view: pipe, conduit, walkway, and pump on levee slope.

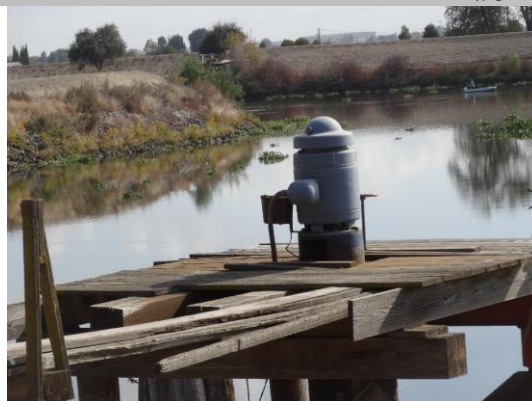
Photo 2 of 3 : UCIP\_FA\_2018\_51351\_41785.jpg

WS view: pump on wooden pile structure in the stream.

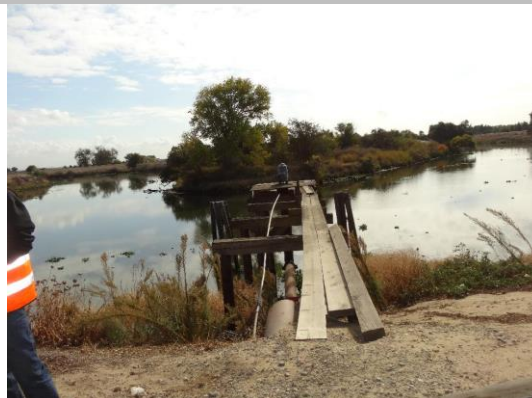
Photo 3 of 3 : UCIP\_FA\_2018\_51351\_41784.jpg

Comment Code						
Inspector Comment						
FS_ID:51351 DS_ID:22648 EP_NO: 4114 Repair Type: Non-Urgent Crossing Status: Found UCIP Comments: 12/22/2016: No signs of erosion or depressions found on either levee slope. Slope may have been backfilled but cause of original depression (likely a pipe integrity problem) may not have been addressed. Walkway still in poor structural condition. Downgraded this crossing from Urgent to Non-Urgent. (K. Fazel - UCIP)10/29/2013:- levee depression on both sides of the levee.- 2-inch electric conduit on waterside and service pole on landside.Walkway in poor structural condition. (P. Amatya - DWR) FIELD_STRUCT_DESC: 18-inch steel irrigation discharge pipe through the levee, 2 feet below the crown. Pump mounted on a pile structure pier in the river. Siphon breaker on the apex of the pipe on the landside (LS) slope. Concrete standpipe at the LS toe. 2-inch electrical conduit through the levee. Service pole at the LS toe. (Plans to install a pump, pump structure, and one 20-inch pipeline through the levee authorized under Permit No. 4114, 1962 - Katie M. Feck). [Additional Reference(s): DWR Levee Log, 2005, 14-inch pipe referenced, 4.2 feet below the crown. USACE San Joaquin O&M Manual 7, April 1964, (HLM 1.73), 20-inch pipe, 4.2 feet below the crown, referenced]. FS Date: 12/22/2016

WS view: depression on levee shoulder near walkway. Half of the walkway stripped off.

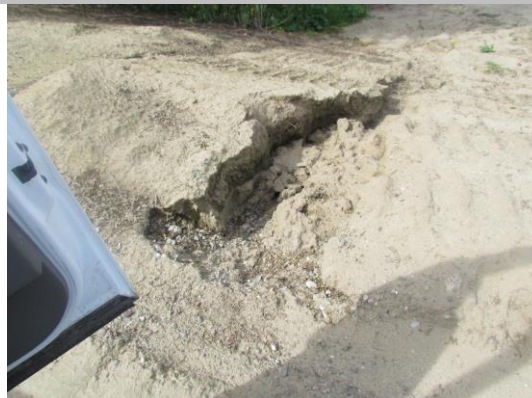
Photo 1 of 2 : FA\_2018\_RD0544\_108\_80\_20180906\_00057.jpg

LM Start	1.82	Rating **	U	Issue No.	80
LM End	1.82	Issue Type +	Ma	Location *	LS
Category	Earthen Levee			GPS Latitude/Longitude	
				Start	End
Item	Erosion / Bank Caving			37.853173 °	37.853173 °
				-121.324145 °	-121.324145 °
DWR ID	DWR_RD0544_01_s_2017_80				
Comment Code					
E2 : Schedule repair of erosion site prior to the next inspection.					
Inspector Comment					
Repair slope damage due to water runoff.

Looking west at slope damage due to rain runoff on waterward slope.

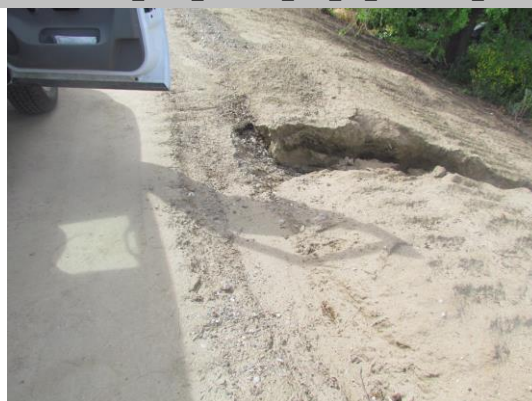
Photo 2 of 2 : FA\_2018\_RD0544\_108\_80\_20180906\_00058.jpg

Looking south at slope damage due to rain runoff on waterward slope.

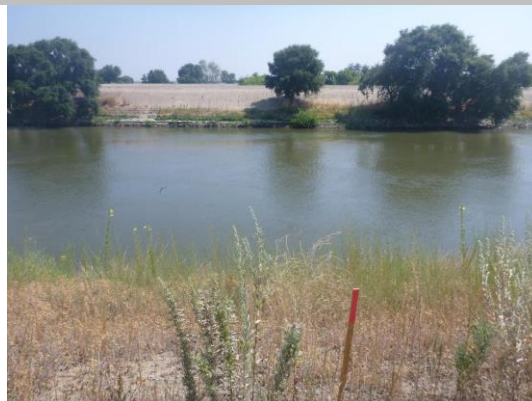
Photo 1 of 3 : LEVAL\_FA\_2018\_569\_4614.jpg

LM Start	1.89	Rating **	A/W	Issue No.	127
LM End	1.91	Issue Type +	Ma	Location *	
Category	Supplemental			GPS Latitude/Longitude	
				Start	End
Item	2017 Storm Damage			37.852300 °	37.852000 °
				-121.323700 °	-121.323600 °
DWR ID	DWR_RD0544_01_f _ 2017_127				
Comment Code					
Inspector Comment					
Levee Evaluation Comments					
Description:Slope protection repairs are needed along the waterside slope due to erosion and riprap displacement from high water. Based upon levee inspections, it was determined the waterside levee slope is eroding, deteriorating, and degrading. The eroded levee sections need to be restored back to design standards to prevent further deterioration and damage.					
Site ID No:569					
Site Designation:LMA-475					
Repair Type: Erosion					
Rating:Area of Concern					
Field Date:8/10/2017					
Notes:

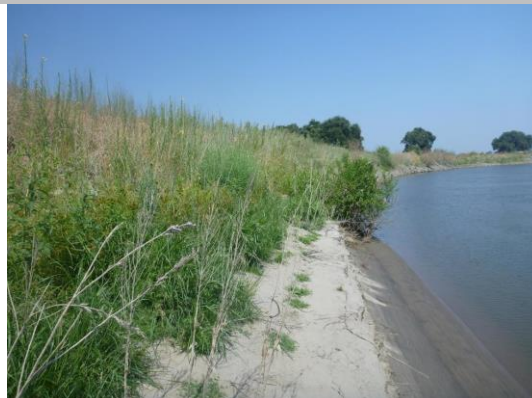
Photo 2 of 3 : LEVAL\_FA\_2018\_569\_4615.jpg

LM Start	1.89	Rating **	A/W	Issue No.	127 (cont)
LM End	1.91	Issue Type +	Ma	Location *	
Category	Supplemental			GPS Latitude/Longitude	
				Start	End
Item	2017 Storm Damage			37.852300 °	37.852000 °
				-121.323700 °	-121.323600 °
DWR ID	DWR_RD0544_01_f_2017_127				
Comment Code					
Inspector Comment					
Levee Evaluation Comments					
Description:Slope protection repairs are needed along the waterside slope due to erosion and riprap displacement from high water. Based upon levee inspections, it was determined the waterside levee slope is eroding, deteriorating, and degrading. The eroded levee sections need to be restored back to design standards to prevent further deterioration and damage.					
Site ID No:569					
Site Designation:LMA-475					
Repair Type: Erosion					
Rating:Area of Concern					
Field Date:8/10/2017					
Notes:

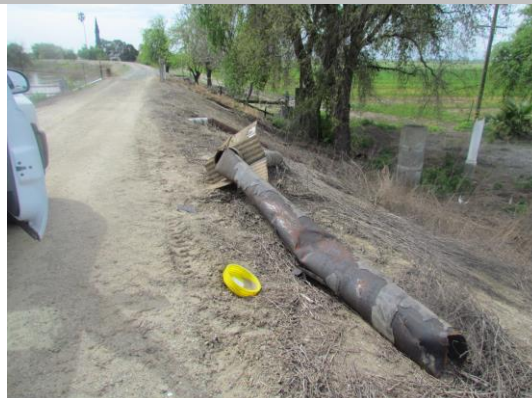
Photo 1 of 1 : FA\_2018\_RD0544\_108\_82\_20180906\_00059.jpg

LM Start	2.25	Rating **	M	Issue No.	82
LM End	2.25	Issue Type +	Ma	Location *	LS
Category	Earthen Levee			GPS Latitude/Longitude	
				Start	End
Item	Encroachments			37.848302 °	37.848302 °
				-121.324877 °	-121.324877 °
DWR ID	DWR_RD0544_01_s_2017_82				
Comment Code					
EQ : Equipment					
Inspector Comment					
Old irrigation pipe.

Looking southwest at old irrigation pipe on landward shoulder.

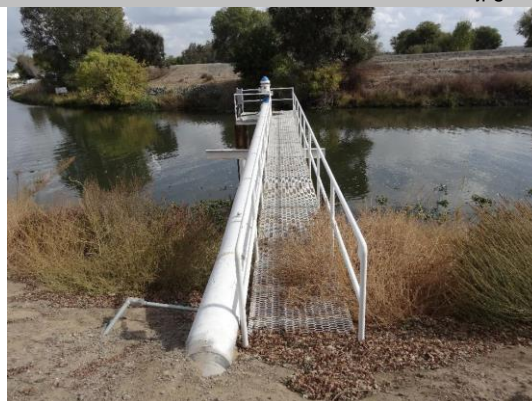
Photo 1 of 3 : UCIP\_FA\_2018\_53362\_42007.jpg

Comment Code						
Inspector Comment						
FS_ID:53362 DS_ID:22650 EP_NO: N/A Repair Type: Urgent Crossing Status: Found UCIP Comments: 10/2/2018 Severe erosion on LS slope so crossing remains Urgent (D. Sanoski - DWR UCIP).12/22/2016: Erosion of LS slope along pipe alignment. (K. Fazel - UCIP)10/29/2013:Siphon breaker on the landward slope not found. It has been removed and pipe plugged.Huge levee slope erosion on landside.2-inch electric conduit on waterside, service pole on landside. (P. Amatya - DWR) FIELD_STRUCT_DESC: 14-inch steel irrigation discharge pipe through the levee, 2 feet below the crown. Pump on a pile structure in the river. Steel walkway to the pump. 2-inch electrical conduit through the levee to the waterside (WS). Power pole on the landside (LS). [Additional Reference(s): DWR Levee Log, 2005, pipe referenced as 5 feet below the crown. USACE San Joaquin O&M Manual 7, April 1964, (HLM 2.26), pipe referenced as 5 feet below the crown]. FS Date: 10/2/2018 2:20:00 PM

WS view: steel pipe, walkway to the pump, conduit (bottom left) on levee slope.

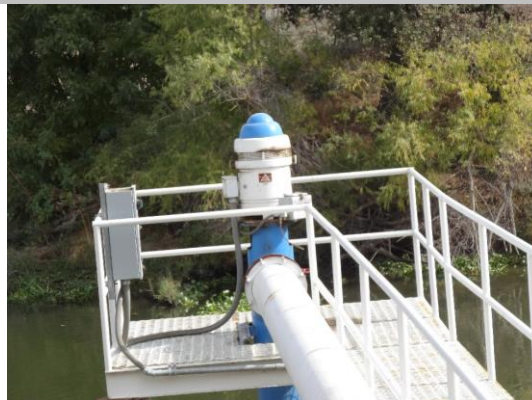
Photo 2 of 3 : UCIP\_FA\_2018\_53362\_42006.jpg

Comment Code						
Inspector Comment						
FS_ID:53362 DS_ID:22650 EP_NO: N/A Repair Type: Urgent Crossing Status: Found UCIP Comments: 10/2/2018 Severe erosion on LS slope so crossing remains Urgent (D. Sanoski - DWR UCIP).12/22/2016: Erosion of LS slope along pipe alignment. (K. Fazel - UCIP)10/29/2013:Siphon breaker on the landward slope not found. It has been removed and pipe plugged.Huge levee slope erosion on landside.2-inch electric conduit on waterside, service pole on landside. (P. Amatya - DWR) FIELD_STRUCT_DESC: 14-inch steel irrigation discharge pipe through the levee, 2 feet below the crown. Pump on a pile structure in the river. Steel walkway to the pump. 2-inch electrical conduit through the levee to the waterside (WS). Power pole on the landside (LS). [Additional Reference(s): DWR Levee Log, 2005, pipe referenced as 5 feet below the crown. USACE San Joaquin O&M Manual 7, April 1964, (HLM 2.26), pipe referenced as 5 feet below the crown]. FS Date: 10/2/2018 2:20:00 PM

WS view: steel pipe, walkway to the pump, and pump on steel pile structure in the stream.

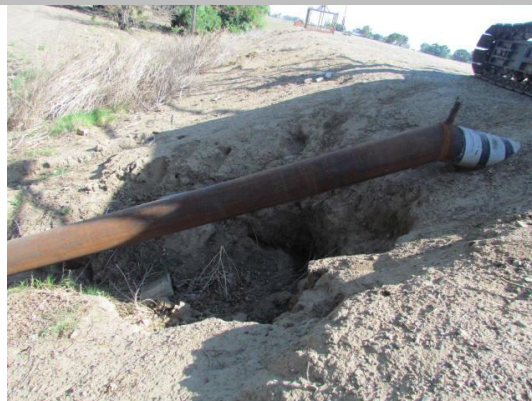
Photo 2 of 3 : FA\_2018\_RD0544\_108\_23\_20180906\_00023.jpg

LM Start	2.25	Rating **	U	Issue No.	23
LM End	2.25	Issue Type +	Ma	Location *	LS
Category	Earthen Levee			GPS Latitude/Longitude	
				Start	End
Item	Erosion / Bank Caving			37.848198°	37.848198°
				-121.324802°	-121.324802°
DWR ID	DWR_RD0544_01_s_2012_23				
Comment Code					
E2 : Schedule repair of erosion site prior to the next inspection.					
Inspector Comment					
Caving/erosion around irrigation pipe on landside slope.

Looking north at erosion under irrigation pipe on landside slope.

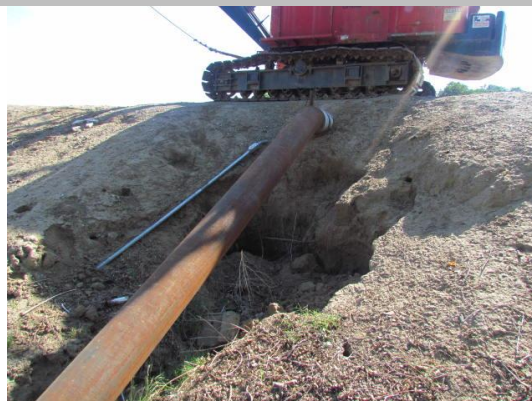
Photo 3 of 3 : FA\_2018\_RD0544\_108\_23\_20180906\_00024.jpg

Looking east at erosion under irrigation pipe on landside slope.

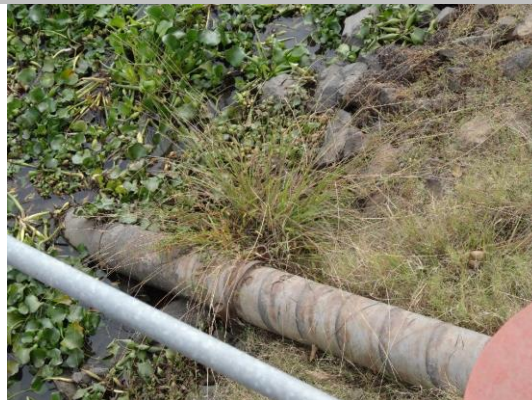
Photo 1 of 3 : UCIP\_FA\_2018\_53363\_44830.jpg

Comment Code					
Inspector Comment					
FS_ID:53363 DS_ID:22652 EP_NO: 13554 Repair Type: Urgent Crossing Status: Found UCIP Comments: 10/2/2018 Significant erosion on LS slope and around pipe, also noticed significant erosion on WS slope so crossing remains as Urgent (D. Sanoski - DWR UCIP).12/22/2016: Depression (hole) in levee in two places on the WS slope in alignment with this pipe. One of the holes is due to rodent activity. Crossing has been upgraded from Non-Urgent to Urgent. (K. Fazel - UCIP)10/29/2013:- levee slope erosion on landside.- needs cleaning of siphon breaker. (P. Amatya - DWR) FIELD_STRUCT_DESC: 12-inch coated steel drainage discharge pipe, 2 feet below the crown. Pump in a concrete standpipe in a drainage ditch at the landside (LS) toe. Siphon breaker in a steel riser on the waterside (WS). (Plans to install a 12-inch discharge pipe through the levee for removal of excess waters authorized under Permit No. 13554, 1982 - Lloyd Phelps Jr). [Additional Reference(s): DWR Levee Log, 2005, states that the pump is on a pier in the channel]. FS Date: 10/2/2018 2:34:00 PM

WS view: steel pipe immersed into the stream.

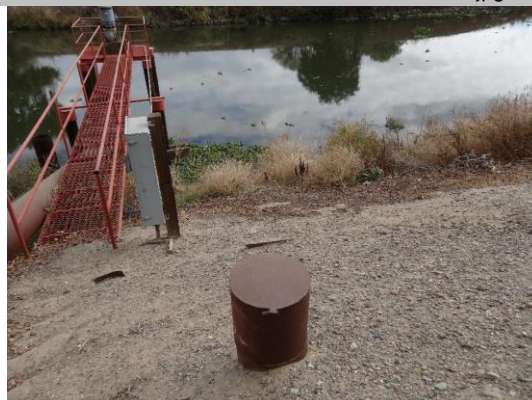
Photo 2 of 3 : UCIP\_FA\_2018\_53363\_44829.jpg

WS view: siphon breaker inside steel pipe riser (bottom) on levee slope.

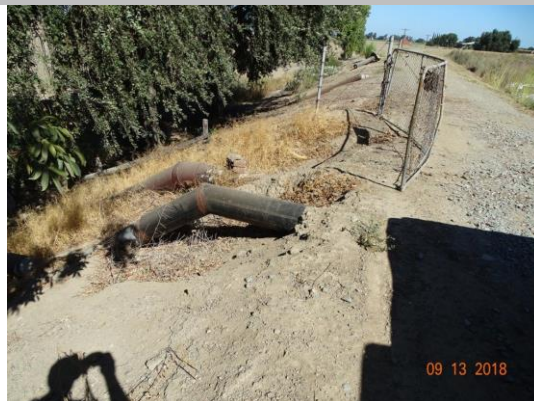
Photo 2 of 3 : FA\_2018\_RD0544\_108\_44\_20180919\_00174.jpg

LM Start	2.27	Rating **	U	Issue No.	44
LM End	2.27	Issue Type +	Ma	Location *	LS
Category	Earthen Levee			GPS Latitude/Longitude	
				Start	End
Item	Erosion / Bank Caving			37.847990 °	37.847990 °
				-121.324897 °	-121.324897 °
DWR ID	DWR_RD0544_01_f_2018_44				
Comment Code					
E2 : Schedule repair of erosion site prior to the next inspection.					
Inspector Comment					
erosion around irrigation pipe on landward slope.

Looking northwest at erosion around irrigation pipe on landward slope. (Fall 2018)

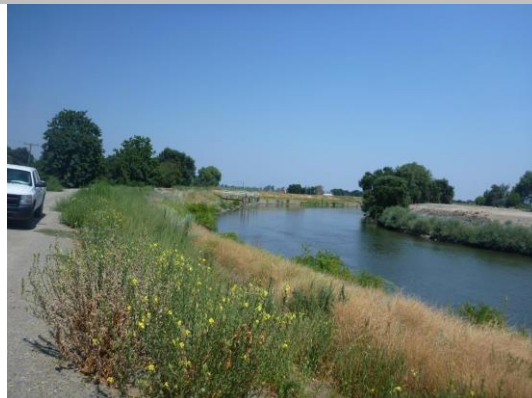
Photo 1 of 3 : LEVAL\_FA\_2018\_568\_4540.jpg

LM Start	2.31	Rating **	A/W	Issue No.	128
LM End	2.35	Issue Type +	Ma	Location *	
Category	Supplemental			GPS Latitude/Longitude	
				Start	End
Item	2017 Storm Damage			37.847300 °	37.846800 °
				-121.324700 °	-121.324400 °
DWR ID	DWR_RD0544_01_f_2017_128				
Comment Code					
Inspector Comment					
Levee Evaluation Comments					
Description:Slope protection repairs are needed along the waterside slope due to erosion and riprap displacement from high water. Based upon levee inspections, it was determined the waterside levee slope is eroding, deteriorating, and degrading. The eroded levee sections need to be restored back to design standards to prevent further deterioration and damage.					
Site ID No:568					
Site Designation:LMA-474					
Repair Type: Erosion					
Rating:Area of Concern					
Field Date:8/10/2017					
Notes:

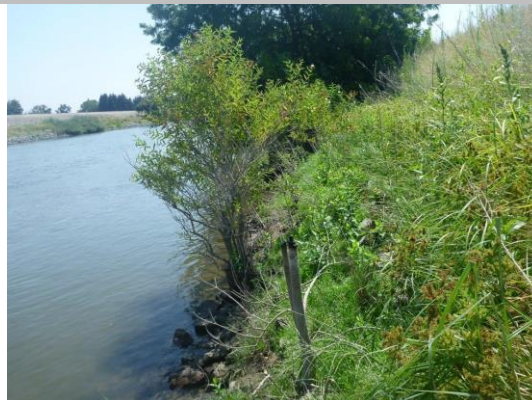
Photo 3 of 3 : LEVAL\_FA\_2018\_568\_4547.jpg

LM Start	2.31	Rating **	A/W	Issue No.	128 (cont)
LM End	2.35	Issue Type +	Ma	Location *	
Category	Supplemental			GPS Latitude/Longitude	
				Start	End
Item	2017 Storm Damage			37.847300 °	37.846800 °
				-121.324700 °	-121.324400 °
DWR ID	DWR_RD0544_01_f _ 2017_128				
Comment Code					
Inspector Comment					
Levee Evaluation Comments					
Description:Slope protection repairs are needed along the waterside slope due to erosion and riprap displacement from high water. Based upon levee inspections, it was determined the waterside levee slope is eroding, deteriorating, and degrading. The eroded levee sections need to be restored back to design standards to prevent further deterioration and damage.					
Site ID No:568					
Site Designation:LMA-474					
Repair Type: Erosion					
Rating:Area of Concern					
Field Date:8/10/2017					
Notes:

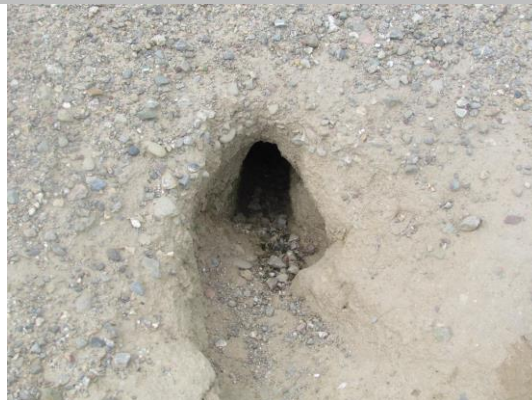
Photo 1 of 3 : FA\_2018\_RD0544\_108\_34\_20180906\_00027.jpg

LM Start	2.32	Rating **	U	Issue No.	34
LM End	2.36	Issue Type +	Ma	Location *	LS
Category	Earthen Levee			GPS Latitude/Longitude	
				Start	End
Item	Animal Control			37.847292°	37.846743°
				-121.324662°	-121.324336°
DWR ID	DWR_RD0544_01_s_2012_34				
Comment Code					
A1 : Exterminate rodents and backfill and compact or grout burrows.					
Inspector Comment					
Several rodent hole within this reach.

Looking east at large rodent hole on landward slope.

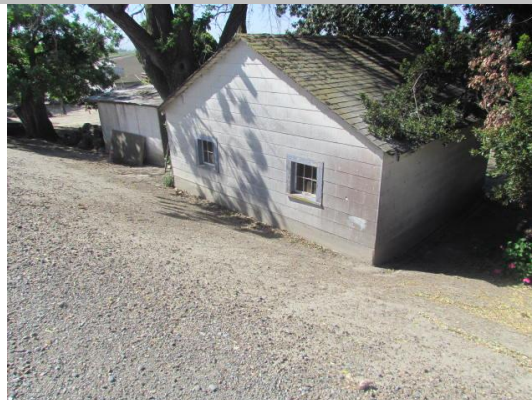
Photo 1 of 1 : FA\_2018\_RD0544\_108\_67\_20180906\_00047.jpg

LM Start	2.38	Rating **	M	Issue No.	67
LM End	2.38	Issue Type +	En	Location *	LS
Category	Earthen Levee			GPS Latitude/Longitude	
				Start	End
Item	Encroachments			37.846508 °	37.846508 °
				-121.324103 °	-121.324103 °
DWR ID	DWR_RD0544_01_s_2013_67				
Comment Code					
BU : Building					
Inspector Comment					
Building has been in place for several years.

Looking southeast at building at landward toe.

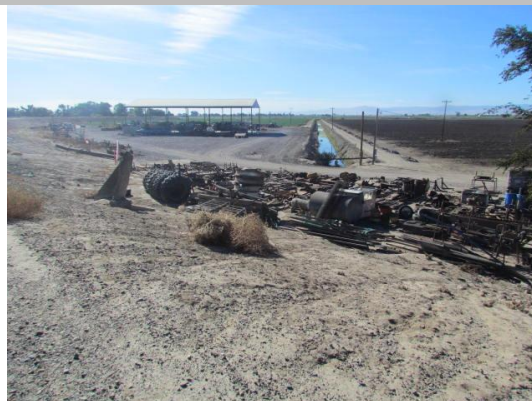
Photo 1 of 1 : FA\_2018\_RD0544\_108\_68\_20180906\_00048.jpg

LM Start	2.40	Rating **	U	Issue No.	68
LM End	2.40	Issue Type +	En	Location *	LS
Category	Earthen Levee			GPS Latitude/Longitude	
				Start	End
Item	Encroachments			37.846315 °	37.846315 °
				-121.323875 °	-121.323875 °
DWR ID	DWR_RD0544_01_s_2013_68				
Comment Code					
EQ : Equipment					
Inspector Comment					
Equipment on landside toe.

Looking west at equipment at landward toe.

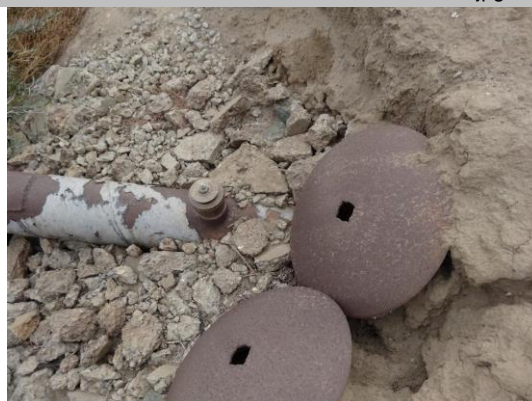
Photo 2 of 3 : UCIP\_FA\_2018\_46671\_44835.jpg

LM Start	2.43	Rating **	M	Issue No.	158 (cont)
LM End	2.43	Issue Type +	En	Location *	
Category	Supplemental			GPS Latitude/Longitude	
				Start	End
Item	DWR UCIP Field Study			37.845968 °	37.845968 °
				-121.323357 °	-121.323357 °
DWR ID	22654				
Comment Code					
Inspector Comment					
FS_ID:46671 DS_ID:22654 EP_NO: N/A Repair Type: Non-Urgent Crossing Status: Found UCIP Comments: - soil around the siphon breaker eroded. FIELD_STRUCT_DESC: 8-inch drainage discharge pipe of an unknown material through the levee, 2 feet below the crown. Siphon breaker on the waterside (WS) slope. Pump on a drainage channel bank on the landside (LS). [Additional Reference(s): DWR Levee Log, 2005]. FS Date: 10/29/2013

WS view: exposed steel pipe and soil erosion around siphon breaker on levee slope.

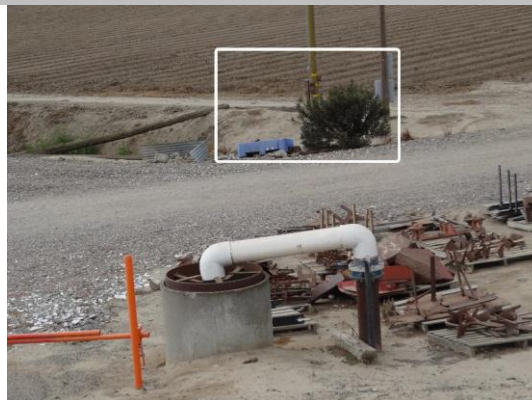
Photo 3 of 3 : UCIP\_FA\_2018\_46671\_44834.jpg

LS view: pump on drainage ditch bank about 140 ft from the levee.

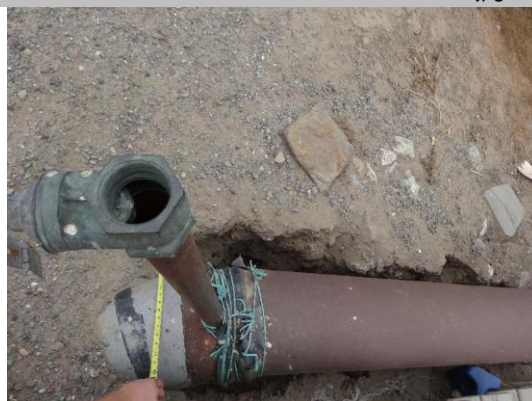
Photo 2 of 3 : UCIP\_FA\_2018\_51361\_44838.jpg

Comment Code						
Inspector Comment						
FS_ID:51361 DS_ID:22655 EP_NO: N/A Repair Type: Non-Urgent Crossing Status: Found UCIP Comments: 12/22/2016: Erosion has been backfilled. Slope has been repaired but unclear if the source of the erosion (a possible leak in pipe) was addressed. Crossing has been downgraded from Urgent to Non-Urgent. (K. Fazel - UCIP)10/29/2013:Siphon breaker on the landward shoulder not found.Service pole on landside.Huge erosion on landside and waterside of the levee due to the pipe leakage. (P. Amatya - DWR) FIELD_STRUCT_DESC: 12-inch steel irrigation discharge pipe through the levee, 2 feet below the crown. Pump mounted on a pile structure in the river. Steel walkway to the pump. Air relief valve on the waterside (WS) shoulder. Concrete distribution box at the landside (LS) toe. [Additional Reference(s): DWR Levee Log, 2005. USACE San Joaquin O&M Manual 7, April 1964, (HLM 2.58), 16-inch pipe, 12 feet below the crown, referenced]. FS Date: 12/22/2016

WS view: exposed pipe, air relief valve, and huge erosion on levee slope.

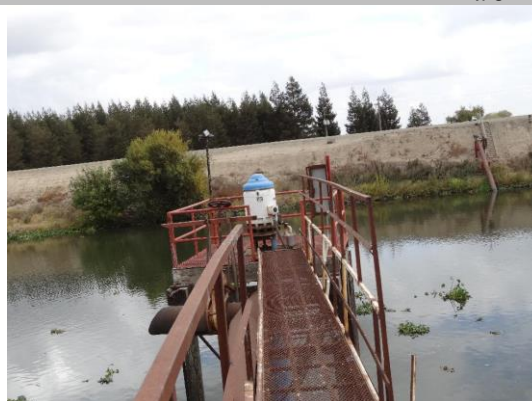
Photo 3 of 3 : UCIP\_FA\_2018\_51361\_44837.jpg

WS view: walkway to pump and pump on pile structure in the stream.

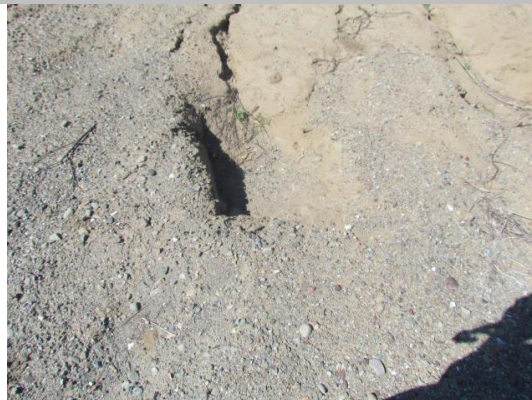
Photo 1 of 2 : FA\_2018\_RD0544\_108\_107\_20180906\_00074.jpg

LM Start	2.95	Rating **	M	Issue No.	107
LM End	2.96	Issue Type +	Ma	Location *	LS
Category	Earthen Levee			GPS Latitude/Longitude	
				Start	End
Item	Erosion / Bank Caving			37.840560°	37.840467°
				-121.318463°	-121.318367°
DWR ID	DWR_RD0544_01_s_2015_107				
Comment Code					
E1 : Note and monitor erosion site.					
Inspector Comment					
Several depressions on landside slope within this reach.

Looking south at depression on landward slope.

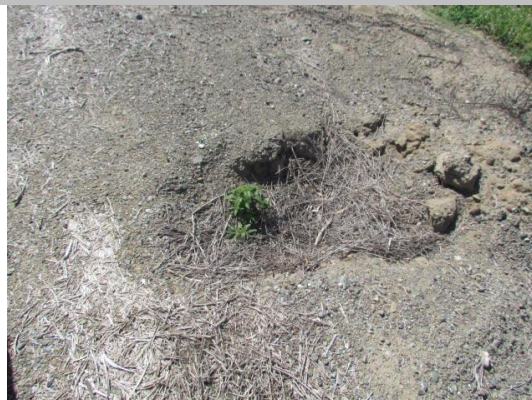
Photo 2 of 2 : FA\_2018\_RD0544\_108\_107\_20180906\_00075.jpg

Looking west at depression on landward shoulder.

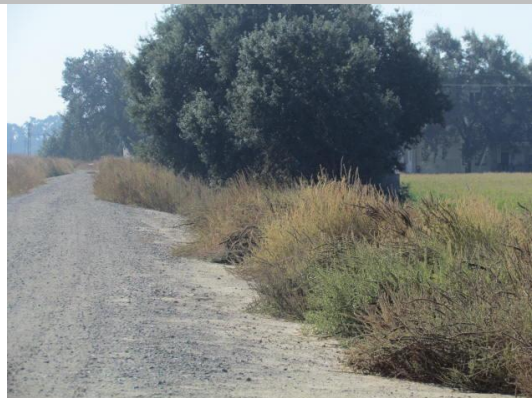
Photo 1 of 1 : FA\_2018\_RD0544\_108\_47\_20180906\_00036.jpg

LM Start	2.95	Rating **	M	Issue No.	47
LM End	3.19	Issue Type +	Ma	Location *	LS
Category	Earthen Levee			GPS Latitude/Longitude	
				Start	End
Item	Vegetation			37.840485 °	37.837225 °
				-121.318390 °	-121.317408 °
DWR ID	DWR_RD0544_01_s_2012_47				
Comment Code					
V2 : Remove the wild growth other than native grasses from the levee slopes.					
Inspector Comment

Looking south at dense veg on landward slope fall 2015.

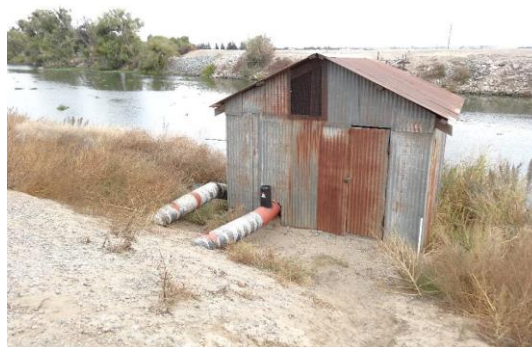
Photo 1 of 3 : UCIP\_FA\_2018\_51365\_42207.jpg

Comment Code					
Inspector Comment					
FS_ID:51365 DS_ID:22656 EP_NO: N/A Repair Type: Non-Urgent Crossing Status: Found UCIP Comments: 12/22/2016: Giant pit in LS slope has been backfilled, though no permit uncovered for this work. Unclear whether original source of damage (likely a leak in pipe) was addressed. Crossing has been downgraded from Urgent to Non-Urgent. (K. Fazel - UCIP)10/29/2013:- huge levee slope erosion on landside. Walkway to distro box on LS toe in poor structural condition.- 1-inch electric conduit, power pole on landside.- not clear whether this is a irrigation or drainage pipe. (P. Amatya - DWR) FIELD_STRUCT_DESC: 1 of 2: 14-inch steel irrigation discharge pipe through the levee, 8 feet below the crown. Slide gate in a 6-foot by 6-foot concrete distribution box at the landside (LS) toe. 1-inch electrical conduit through the levee. Power pole at the LS toe. Pump house on the waterside (WS) slope, but no pump attached as per the 2013 inspection. Flow meter on the WS. [Additional Reference(s): DWR Levee Log, 2005. USACE San Joaquin O&M Manual 7, April 1964, (HLM 3.19)]. FS Date: 12/22/2016

WS view: exposed steel pipes, levee slope, and pumphouse for 2nd pipe.

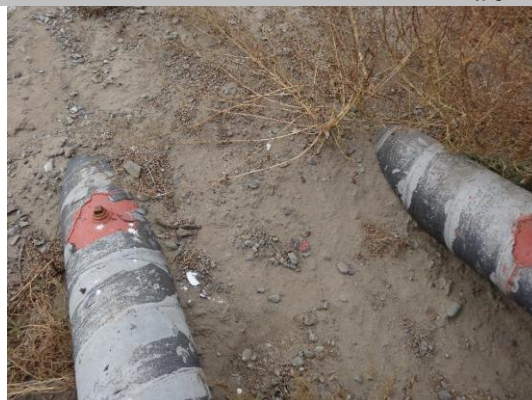
Photo 2 of 3 : UCIP\_FA\_2018\_51365\_42206.jpg

WS view: exposed steel pipes on levee slope.

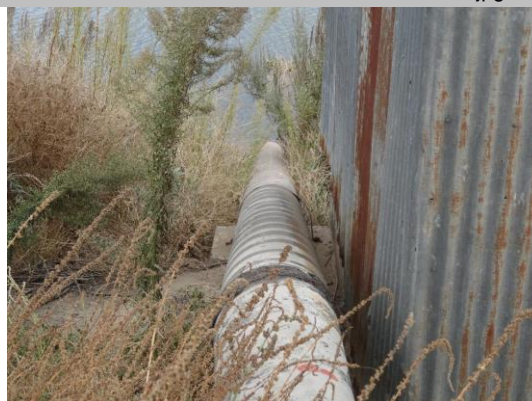
Photo 3 of 3 : UCIP\_FA\_2018\_51365\_42205.jpg

Comment Code						
Inspector Comment						
FS_ID:51365 DS_ID:22656 EP_NO: N/A Repair Type: Non-Urgent Crossing Status: Found UCIP Comments: 12/22/2016: Giant pit in LS slope has been backfilled, though no permit uncovered for this work. Unclear whether original source of damage (likely a leak in pipe) was addressed. Crossing has been downgraded from Urgent to Non-Urgent. (K. Fazel - UCIP)10/29/2013:- huge levee slope erosion on landside. Walkway to distro box on LS toe in poor structural condition.- 1-inch electric conduit, power pole on landside.- not clear whether this is a irrigation or drainage pipe. (P. Amatya - DWR) FIELD_STRUCT_DESC: 1 of 2: 14-inch steel irrigation discharge pipe through the levee, 8 feet below the crown. Slide gate in a 6-foot by 6-foot concrete distribution box at the landside (LS) toe. 1-inch electrical conduit through the levee. Power pole at the LS toe. Pump house on the waterside (WS) slope, but no pump attached as per the 2013 inspection. Flow meter on the WS. [Additional Reference(s): DWR Levee Log, 2005. USACE San Joaquin O&M Manual 7, April 1964, (HLM 3.19)]. FS Date: 12/22/2016

WS view: exposed steel pipe immersed into the stream. No pump attached.

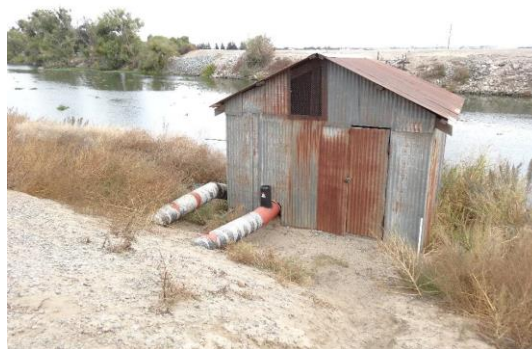
Photo 1 of 3 : UCIP\_FA\_2018\_51366\_44845.jpg

Comment Code					
Inspector Comment					
FS_ID:51366 DS_ID:22681 EP_NO: N/A Repair Type: Non-Urgent Crossing Status: Found UCIP Comments: 12/22/2016: Giant pit in LS slope has been backfilled, though no permit uncovered for this work. Unclear whether original source of damage (likely a leak in pipe) was addressed. Crossing has been downgraded from Urgent to Non-Urgent. (K. Fazel - UCIP)10/29/2013:Huge erosion and levee damage on landside slope due to the leaky pipe. Walkway to distro box on LS toe in poor structural condition. (P. Amatya - DWR) FIELD_STRUCT_DESC: 2 of 2: 14-inch steel irrigation discharge pipe through the levee, 8 feet below the crown. Slide gate in a 6-foot by 6-foot concrete distribution box at the landside (LS) toe. 1-inch electrical conduit through the levee. Power pole at the LS toe. Pump house on the waterside (WS) slope, but no pump attached as per the 2013 inspection. Flow meter on the WS. [Additional Reference(s): DWR Levee Log, 2005. USACE San Joaquin O&M Manual 7, April 1964, (HLM 3.19)]. FS Date: 12/22/2016

WS view: exposed steel pipes, levee slope, and pumphouse.

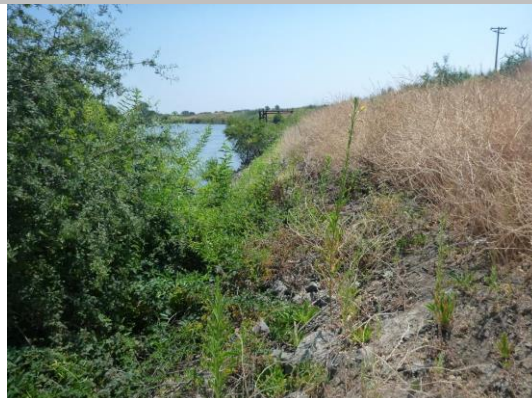
Photo 1 of 3 : LEVAL\_FA\_2018\_566\_4714.jpg

LM Start	3.21	Rating **	A/W	Issue No.	131
LM End	3.22	Issue Type +	Ma	Location *	
Category	Supplemental			GPS Latitude/Longitude	
				Start	End
Item	2017 Storm Damage			37.836900 °	37.836700 °
				-121.317300 °	-121.317300 °
DWR ID	DWR_RD0544_01_f_2017_131				
Comment Code					
Inspector Comment					
Levee Evaluation Comments					
Description:Slope protection repairs are needed along the waterside slope due to erosion and riprap displacement from high water. Based upon levee inspections, it was determined the waterside levee slope is eroding, deteriorating, and degrading. The eroded levee sections need to be restored back to design standards to prevent further deterioration and damage.					
Site ID No:566					
Site Designation:LMA-472					
Repair Type: Erosion					
Rating:Area of Concern					
Field Date:8/10/2017					
Notes:

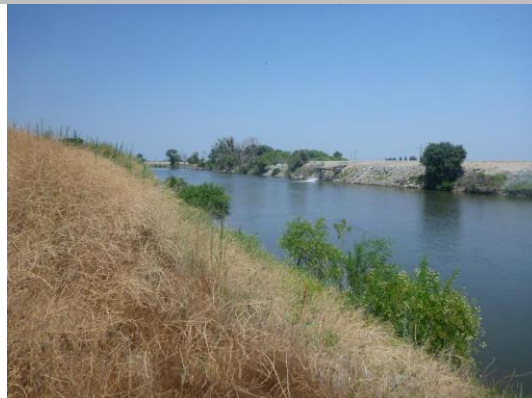
Photo 3 of 3 : LEVAL\_FA\_2018\_566\_4722.jpg

LM Start	3.21	Rating **	A/W	Issue No.	131 (cont)	
LM End	3.22	Issue Type +	Ma	Location *		
Category	Supplemental			GPS Latitude/Longitude		
				Start	End	
Item	2017 Storm Damage			37.836900 °	37.836700 °	
				-121.317300 °	-121.317300 °	
DWR ID	DWR_RD0544_01_f_2017_131					
Comment Code						
Inspector Comment						
Levee Evaluation Comments						
Description:Slope protection repairs are needed along the waterside slope due to erosion and riprap displacement from high water. Based upon levee inspections, it was determined the waterside levee slope is eroding, deteriorating, and degrading. The eroded levee sections need to be restored back to design standards to prevent further deterioration and damage.						
Site ID No:566						
Site Designation:LMA-472						
Repair Type: Erosion						
Rating:Area of Concern						
Field Date:8/10/2017						
Notes:

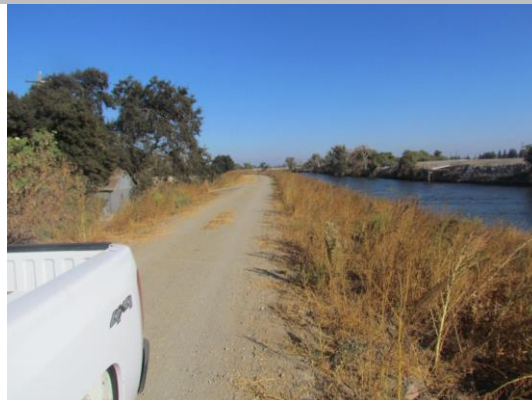
Photo 1 of 1 : FA\_2018\_RD0544\_108\_49\_20180906\_00038.jpg

LM Start	3.22	Rating **	U	Issue No.	49
LM End	3.84	Issue Type +	Ma	Location *	WS
Category	Earthen Levee			GPS Latitude/Longitude	
				Start	End
Item	Vegetation			37.836763°	37.829195°
				-121.317307°	-121.311918°
DWR ID	DWR_RD0544_01_s_2012_49				
Comment Code					
V2 : Remove the wild growth other than native grasses from the levee slopes.					
Inspector Comment					
Dense vegetation on waterside slope.

Looking northeast at dense veg on waterward slope.

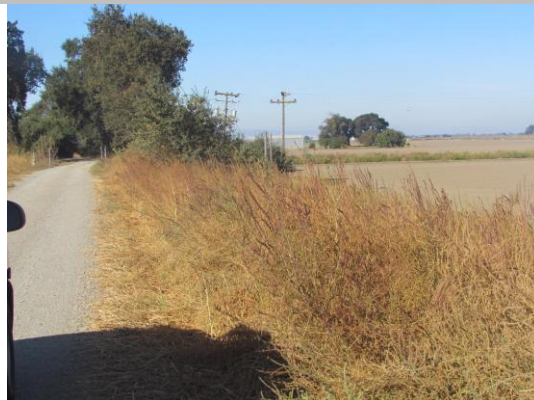
Photo 1 of 1 : FA\_2018\_RD0544\_108\_48\_20180906\_00037.jpg

LM Start	3.23	Rating **	U	Issue No.	48
LM End	3.26	Issue Type +	Ma	Location *	LS
Category	Earthen Levee			GPS Latitude/Longitude	
				Start	End
Item	Vegetation			37.836615 °	37.836133 °
				-121.317285 °	-121.317153 °
DWR ID	DWR_RD0544_01_s_2012_48				
Comment Code					
V2 : Remove the wild growth other than native grasses from the levee slopes.					
Inspector Comment

Looking south at typical view of dense veg on landward slope.

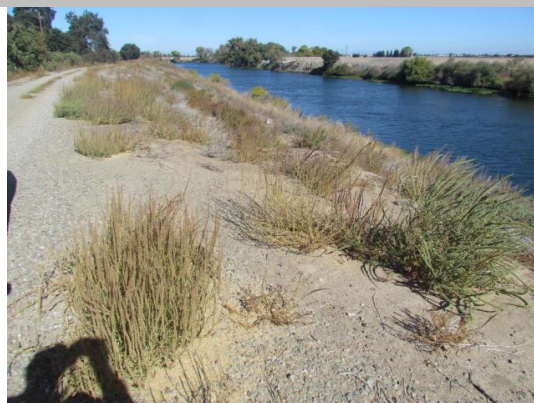
Photo 1 of 1 : FA\_2018\_RD0544\_108\_37\_20180906\_00030.jpg

LM Start	3.28	Rating **	M	Issue No.	37
LM End	3.28	Issue Type +	En	Location *	WS
Category	Earthen Levee			GPS Latitude/Longitude	
				Start	End
Item	Encroachments			37.835951 °	37.835951 °
				-121.317062 °	-121.317062 °
DWR ID	DWR_RD0544_01_s_2012_37				
Comment Code					
RA : Ramp					
Inspector Comment					
Landowner has cut new ramp on waterside slope.

Looking north at ramp on waterward slope.

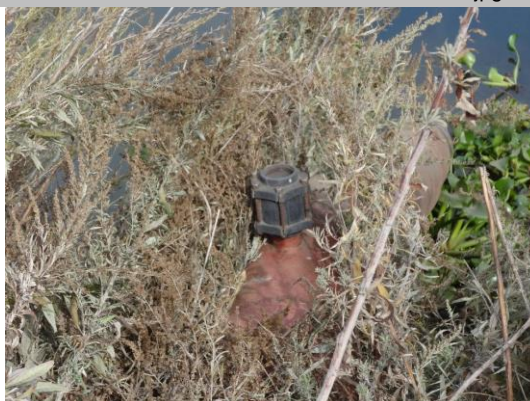
Photo 1 of 3 : UCIP\_FA\_2018\_24892\_44853.jpg

Comment Code						
Inspector Comment						
FS_ID:24892						
DS_ID:22658						
EP_NO: N/A						
Repair Type: No Action Needed						
Crossing Status: Found						
UCIP Comments: - pipe on channel bank looks comparatively new.- pump approximately 500 ft. from the levee center on landside in drainage ditch.- a tall concrete standpipe and service pole near the pump.						
FIELD_STRUCT_DESC: 12-inch steel drainage discharge pipe through the levee, 3 feet below the crown. Pump and concrete standpipe in a drainage ditch on the landside (LS). Air vent on the waterside (WS). [Additional Reference(s): DWR Levee Log, 2005. USACE San Joaquin O&M Manual 7, April 1964, (HLM 3.53)].						
FS Date: 10/29/2013

WS view: exposed steel pipe on bank of the channel.

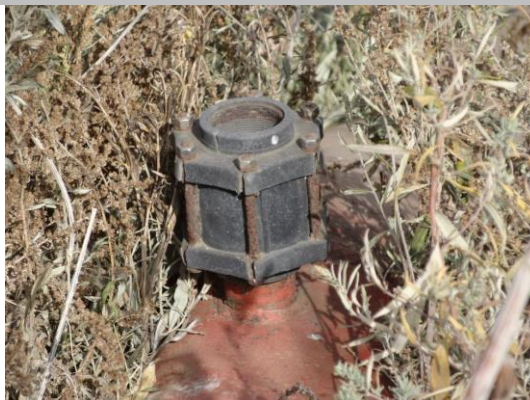
Photo 2 of 3 : UCIP\_FA\_2018\_24892\_44852.jpg

WS view: exposed steel pipe and air vent on the pipe.

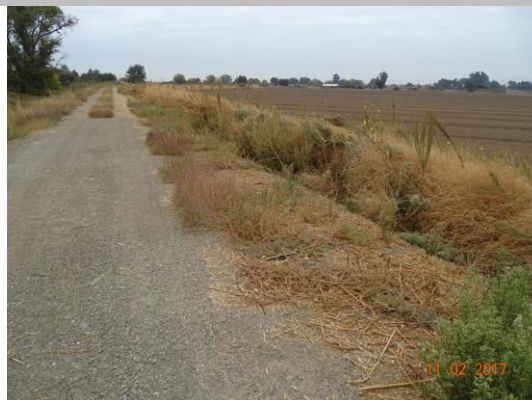
Photo 1 of 1 : FA\_2018\_RD0544\_108\_51\_20180906\_00039.jpg

LM Start	3.49	Rating **	U	Issue No.	51
LM End	4.67	Issue Type +	Ma	Location *	LS
Category	Earthen Levee			GPS Latitude/Longitude	
				Start	End
Item	Vegetation			37.833432 °	37.821853 °
				-121.314792 °	-121.319992 °
DWR ID	DWR_RD0544_01_s_2012_51				
Comment Code					
V2 : Remove the wild growth other than native grasses from the levee slopes.					
Inspector Comment

Looking southeast at the landside slope.
